# METHODS FOR ENHANCED CLEANING OF FOULED RO ELEMENTS

**Authors:** Keith Andes, Craig R. Bartels, PhD, Eric Liu, PhD, Nicholas Sheehy

## **Abstract**

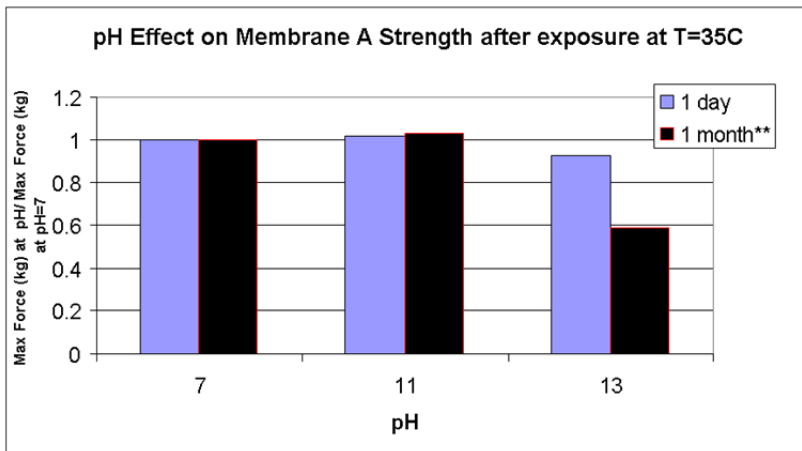
Figure 2B Effect of high pH on membrane strength

The salt rejection of the membrane was virtually the same, whether soaked at pH 7, 11, or 13. However, the samples soaked at these conditions, but then subjected to a mechanical elongation test, showed a much different result. At pH 7 and 11, the mechanical strength for 1 day and 1 month of soaking was unaffected. The sample soaked at pH 13 showed a slight loss of strength at 1 day of soaking, but as much as 40% loss in strength for a 1 month soak. Analysis of these results reveals the cause of the membrane failure. It is apparent that the high pH cleaner did not affect the polyamide layer, since the separation characteristic was not affected. However, the loss in mechanical strength indicates that the fabric backing is being damaged. Thus, as stated above the limit of long-term caustic exposure is limited by the polyester backing, which is common to most all RO membranes.

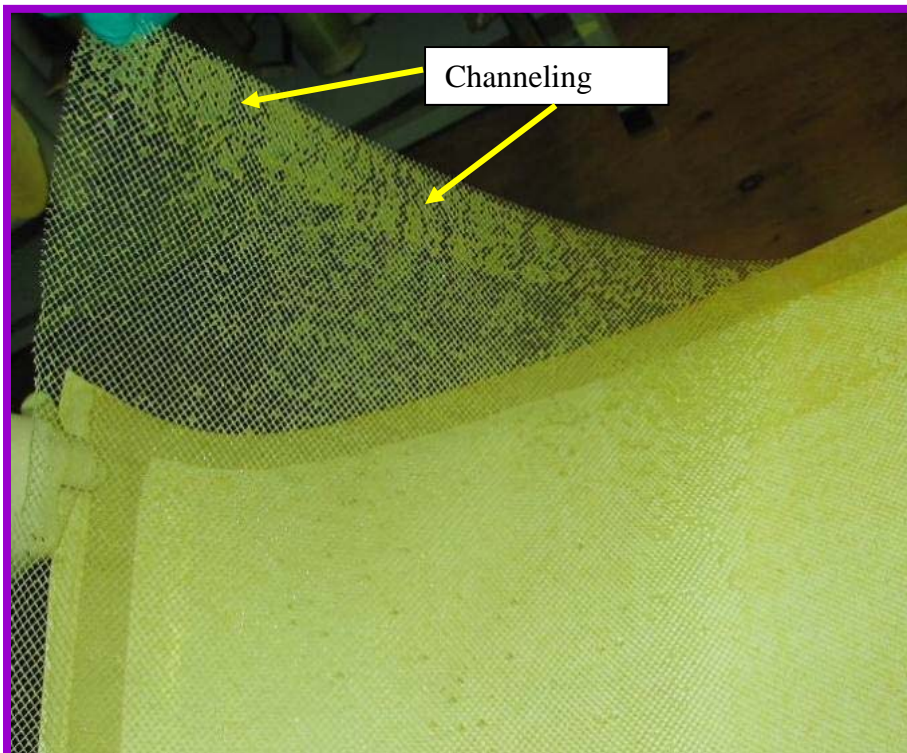
Figure 4 Fouled feedspacer from used element

The fouling or plugging of this spacer can be extensive, especially when there is excessive biofouling or scaling. An example of biofouled feed spacer is shown in Figure 4. When this occurs, there is generally channeling in the foulant, which allows feed to pass to the brine side of the element through small channels. Due to the restricted size of these channels, there is a resultant, higher pressure drop for the

feed to pass through the element. These channels can be clearly seen in the spacer of Figure 4. This picture also demonstrates that the plugging of the feed spacer usually occurs at the feed side of the element, and we find it is most extensive in the first element of the vessel. Because of the increased differential pressure and greater forces on the spacer, it is possible that the spacer will start to push out the brine side of the element, and the leaves may start to telescope. This causes damage to the membrane material, and should be avoided.

The advantage of reverse cleaning is that certain types of foulants concentrate on the feed end of the lead membrane, as shown in Figure 4. Biological foulants, particulates, and colloidal matter are examples of foulants that usually are present on the lead end of the feed membrane. Normal cleaning must break up these foulants and push the foulant through all of the other membranes in the pressure vessel to exit out the brine side. With reverse cleaning, it becomes more of a physical process of “pushing” the foulant out through the feed end, the shortest path length to leave the element.
